AEROBEE 150 PROPULSION FAILURE

by J. R. Busse and P. S. Bushnell, Jr.

*Goddard Space Flight Center
Greenbelt, Md.*

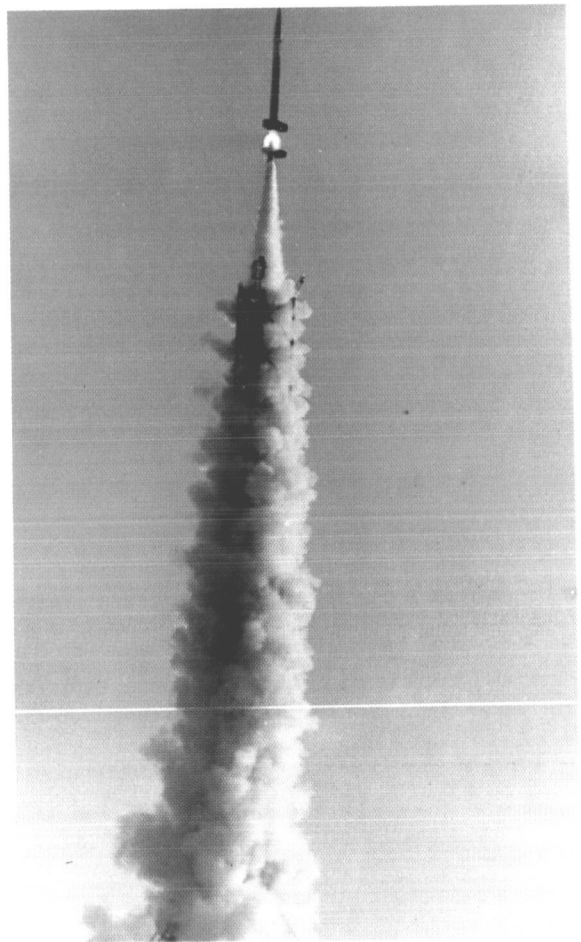
Figure 2—A normal Aerobee 150 leaving the tower at WSMR (NASA 4.67 NP).

The firing of NASA 4.113 GA-GI was accompanied by a loud bang and the rocket emitted an unusual sound variously described as a whine, a scream, or a low-pitched whistle in leaving the tower. The flame and smoke did not appear normal, the booster being partially obscured by a dense cloud of smoke which was reddish brown (Figure 1), in contrast to the usual orange sustainer flame and almost gray-white exhaust trail from the booster propellant combustion of normal flights (Figure 2).

Compare the normal flame in Figure 2 of Aerobee 4.67 NP with the flame in Figure 1 of NASA 4.113 GA-GI. The flame in Figure 1 is shorter but wider, and the booster is almost obscured from view by the dense smoke which starts well forward of the booster. Normally, the booster fins are easily identifiable since the normal gray-white smoke comes from the booster. However, it is seen in Figure 1 that the smoke, instead of the normal orange flame, also came from the sustainer motor.

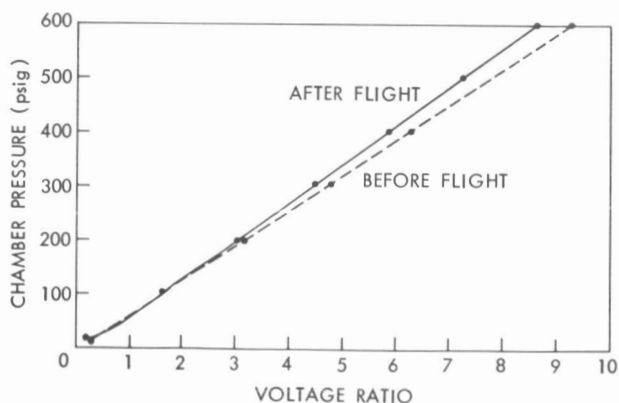
Figure 10—Comparison of preflight and postflight pressure transducer calibration.

Telemetry data based on voltage ratios from preflight calibration curves (Figure 10) show that chamber pressure rose rapidly to 190 psia at 0.06 seconds after ignition and continued to build up erratically, reaching a maximum of 330 psia at 0.49 seconds (Figure 11). (Presumably the frequency response of the Giannini pressure transducer was inadequate to record the maximum pressure encountered during the hard start.) It then fell off drastically. The initial peak followed by the erratic buildup and sharp dropoff were significant factors indicating areas for investigation.

Chamber pressure data from 0.8 seconds to the loss of the signal at 27.5 seconds, based on a recalibration of the transducer, is shown in Figure 12. The postflight chamber pressure transducer calibrations were slightly higher than the manufacturer's plotted calibration (Figures 10 and 12). Chamber pressure began to increase at 23.5 seconds of flight and at 27.5 seconds, the point at which telemetry was lost, the transducer gage read 85 psi (which was subsequently presumed to be tail can pressure).

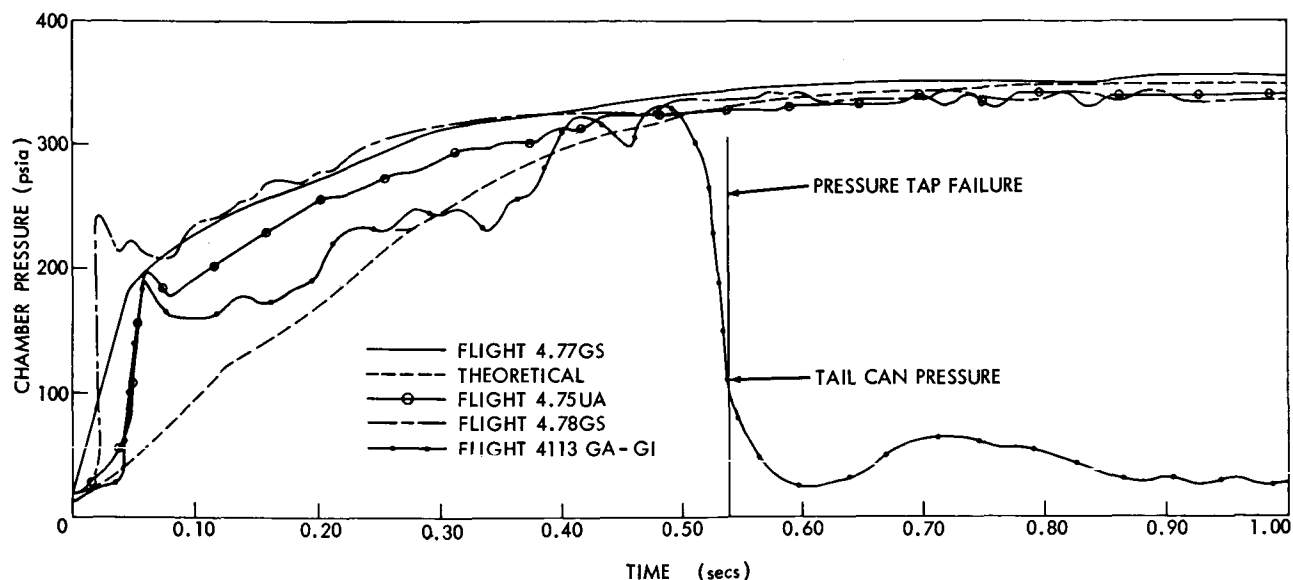
Figure 13—Comparative start transient chamber pressure data.

Figure 13 presents several normal chamber pressure transducer plots compared to the start transient trace for NASA 4.113 GA-GI. Also included is a theoretical chamber pressure curve. The erratic performance of NASA 4.113 GA-GI can readily be noted.

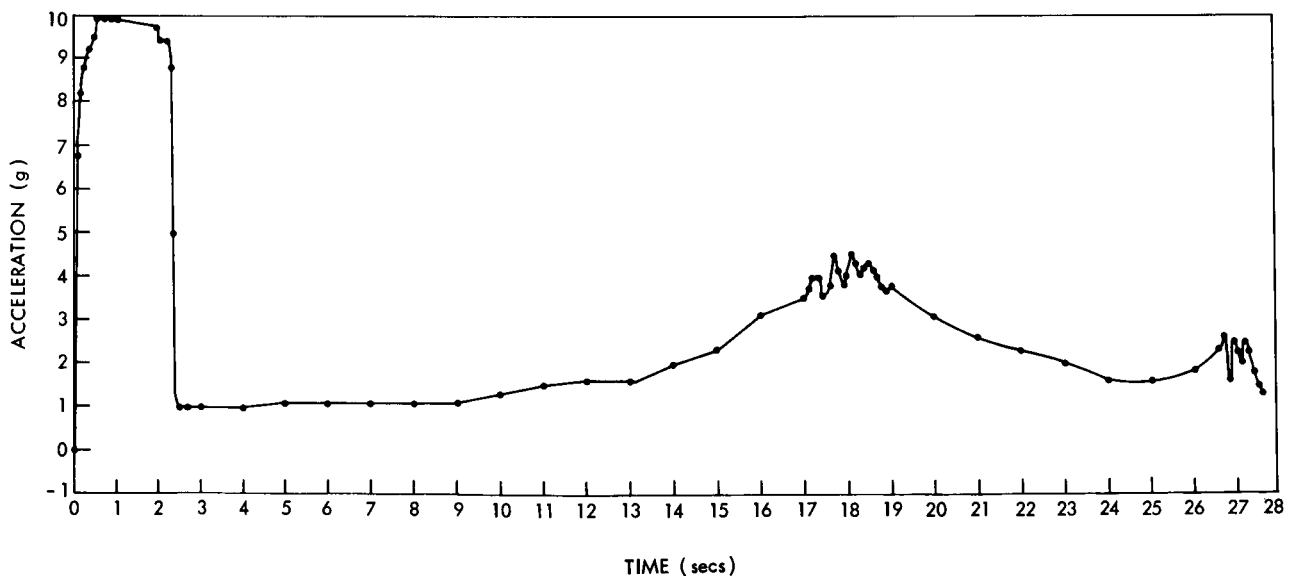
Figure 14—Telemetry acceleration data.

Acceleration curves were plotted from both telemetry (Figure 14) and Contraves data (Figure 15). The telemetry acceleration data are now considered to be of questionable value compared to the more reliable data produced from Contraves optical tracking, which was excellent throughout the flight.

From telemetry, acceleration began to increase again at 9 seconds, reaching 1.6 g at 12 seconds. It increased again at 13 seconds reaching 3.5 g at 17 seconds. Between 17 and 19 seconds, it reached four major peaks, fluctuating between 3.5 to 4.5 g. No explanation has been deduced for this abnormal behavior, other than that it was possibly due to accelerometer resonance during flight caused by the erratic chamber operation, or rocket coning motion producing a centrifugal acceleration. Acceleration decreased gradually to 1.6 g between 19 and 24 seconds. At 25 seconds, another period of erratic acceleration was experienced until telemetry was lost at 27.5 seconds.

The acceleration data substantiate the failure of the pressure tap, as the observed acceleration could not have been obtained from chamber pressure as that recorded by the transducer.

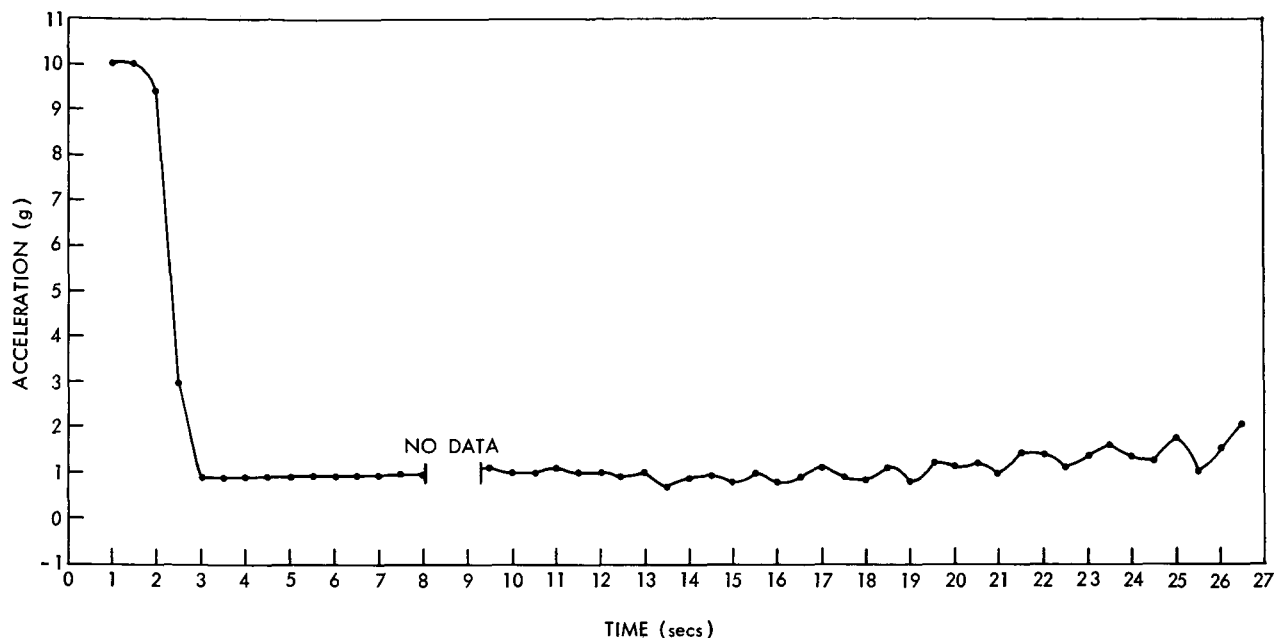
Figure 15—Contraves optical tracking acceleration data.

According to Contraves optical tracking data, acceleration did not drop below 1 g from 9.4 seconds until the loss of Contraves data at 26.5 seconds, and reached peaks of 1.75 g and 2.2 g at 25 seconds and 26.5 seconds, respectively. Generally, observed acceleration was a little low, although not

too abnormal. This performance could be obtained from a rocket operating under an extreme mixture ratio condition. (The normal 150 mixture ratio is 2.56 to 1, oxidizer to fuel.)

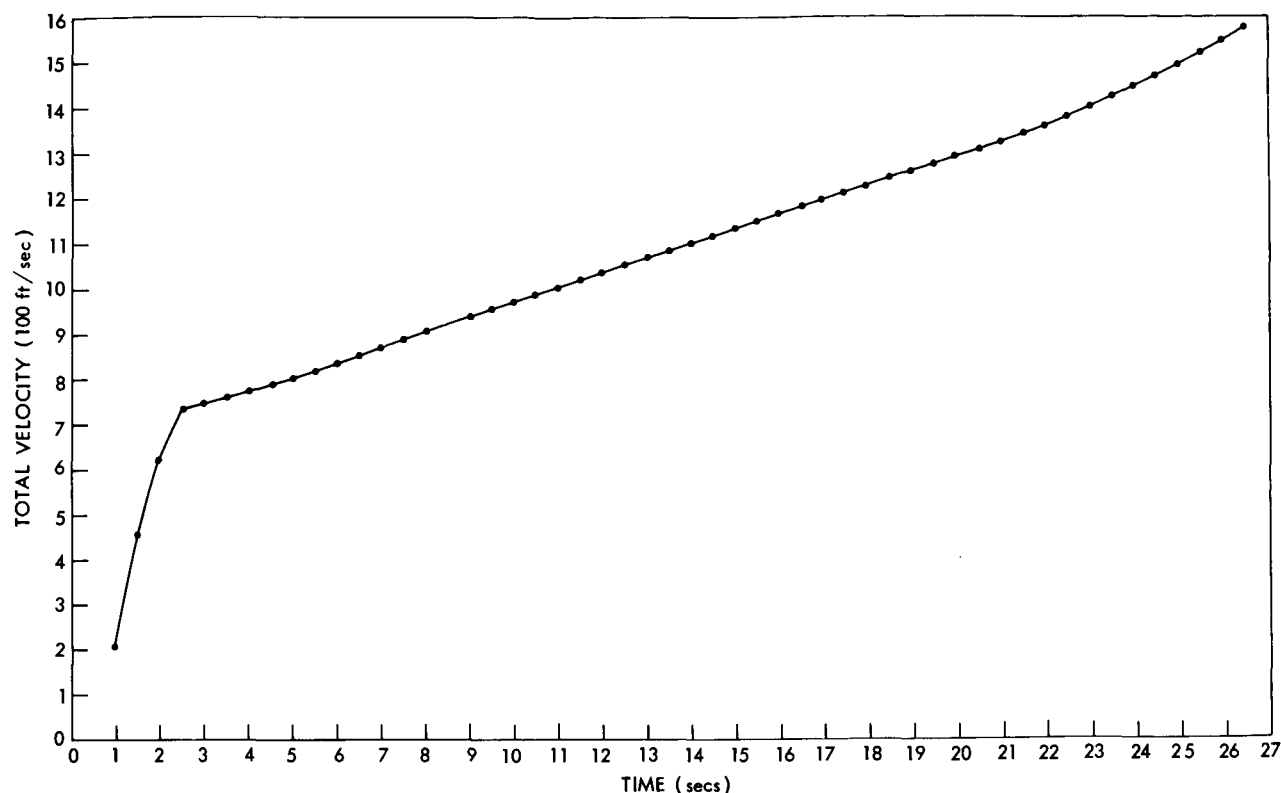
Figure 16—Contraves trajectory velocity data.

The velocity data received from reduced Contraves trajectory data indicated that the rocket was traveling at 735 fps at booster burnout (Figure 16). The velocity at 26.5 seconds, when tracking was lost, was 1575 fps. A later integration of acceleration curves from Contraves and telemetry instrumentation data indicated velocities of 1644 and 2292 fps, respectively, the latter being less reliable data. Compared to the velocity expected of a normal Aerobee 150 flight, the observed velocities were low but the increase was steady.

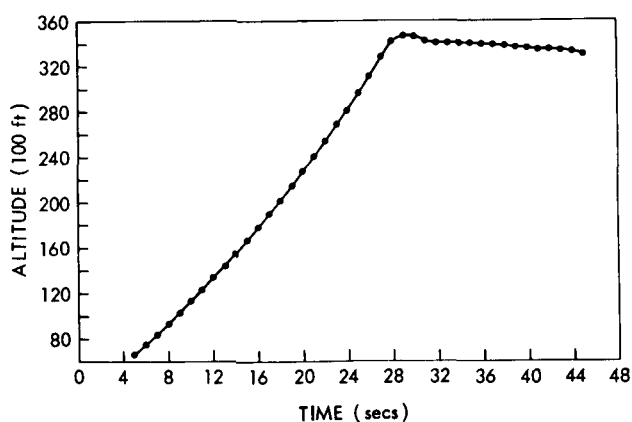
Figure 17—Altitude vs. time (smoothed radar).

Figure 17 shows the altitude performance for the flight plotted from smoothed radar data. Figure 18 illustrates an expected performance trajectory for a rocket of similar payload weight and launch elevation. The sustainer should have burned out at 51.8 seconds at an altitude of 129,445 feet. Actually, all combustion was completed between 46 and 47 seconds, with a loss of effective propulsion at 27.4 seconds when the tail can was lost and the vehicle went into a violent tumbling and flat spinning motion. It was the tumbling (high drag) rocket motion which caused the vehicle to descend slowly. Whereas the altitude at 27.4 seconds should have been somewhere between 40,000-50,000 feet, it was only 34,000 feet.
